CITY OF BOSTON
BOSTON, MASSACHUSETTS

REPORT
OF
INVESTIGATION OF COLLAPSE
AT
HOTEL VENDOME

AUGUST, 1972

MAIN
CHAS. T. MAIN, INC.
Engineers

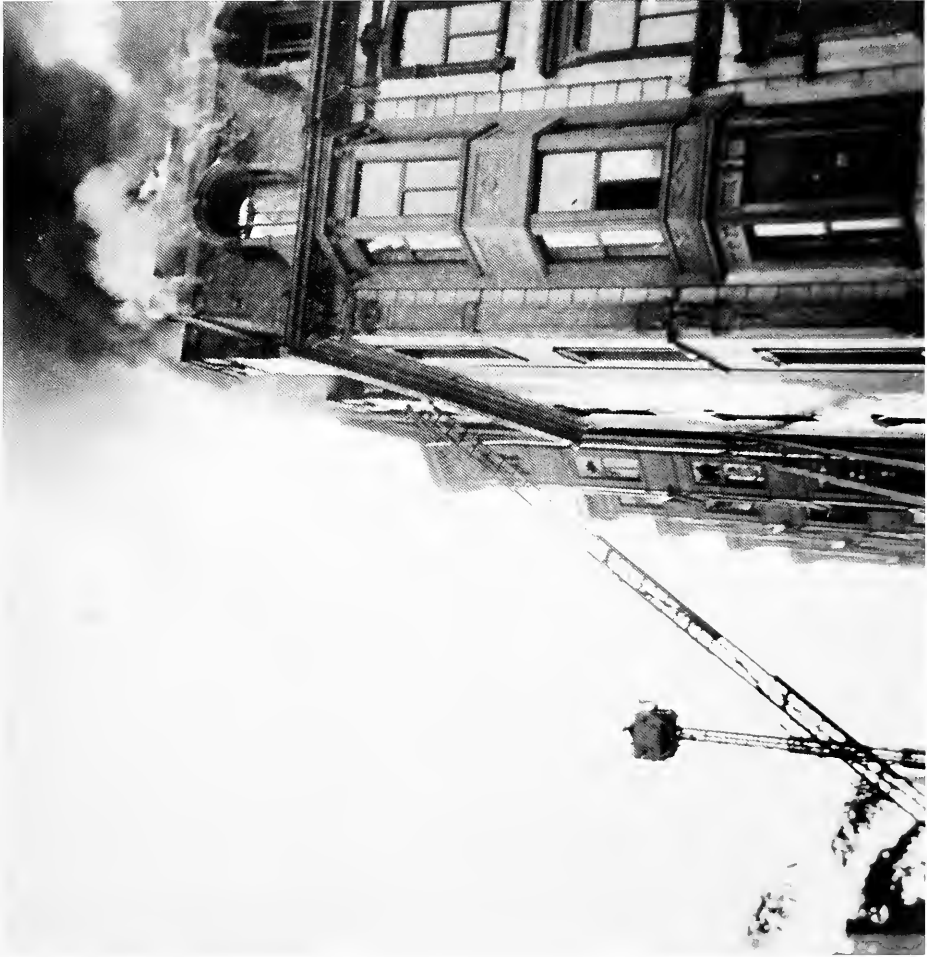
NO. 39

SOUTHEAST CORNER BEFORE COLLAPSE-
NOTE INTENSE FIRE IN ROOF STRUCTURE.
PHOTOGRAPH TAKEN BY JAMES B. FORGIE

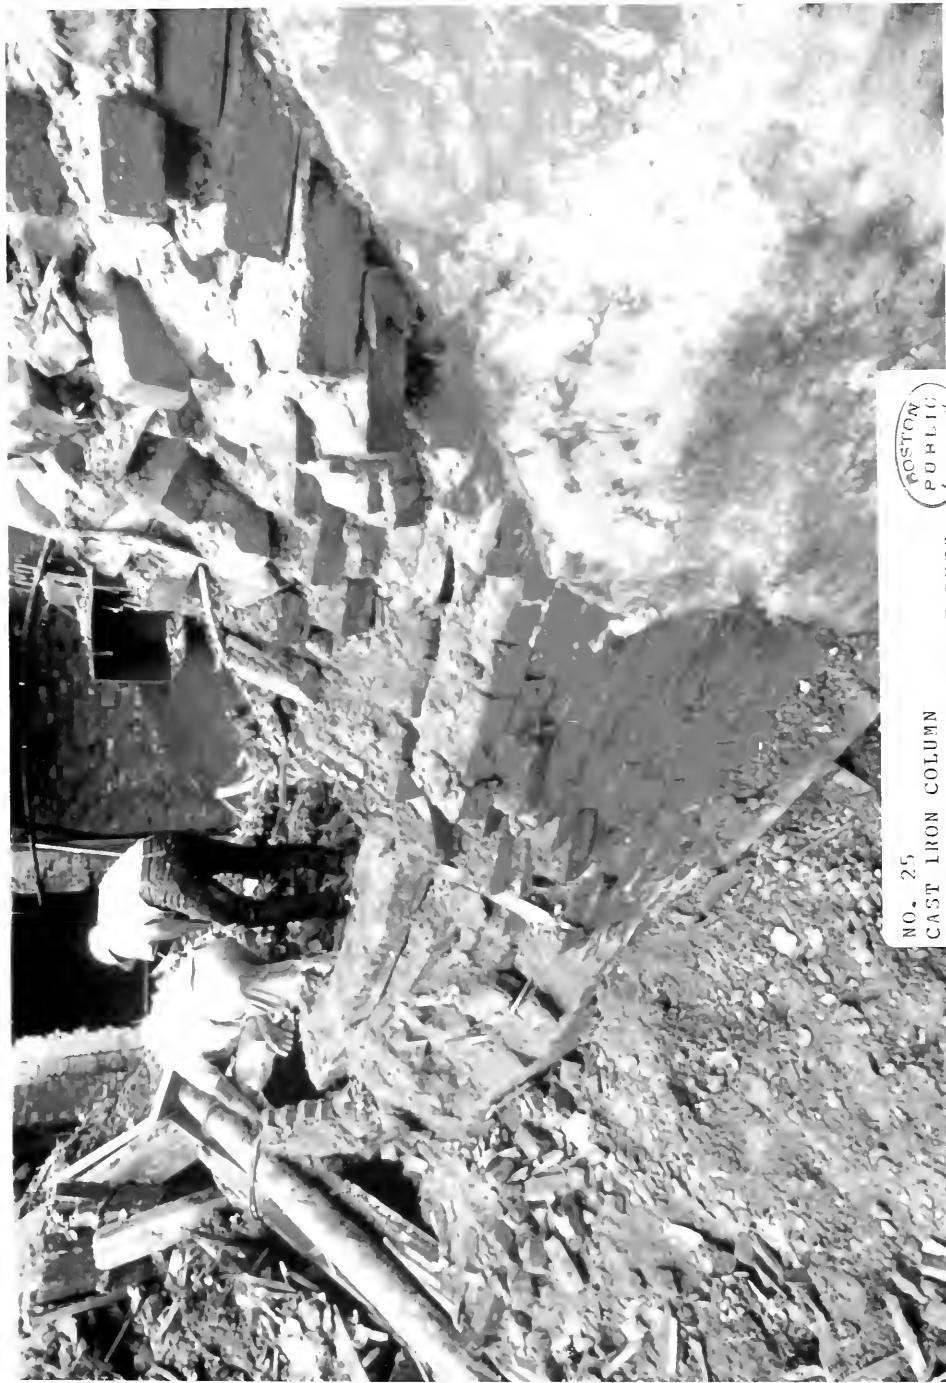
NO. 25

CAST IRON COLUMN
RESTING ON CRUSHED VENT DUCT
IN DOOR OPENING—

NOTE GRANITE BLOCK BEYOND—
NOTE CONDITION OF CENTRAL BEARING WALL.

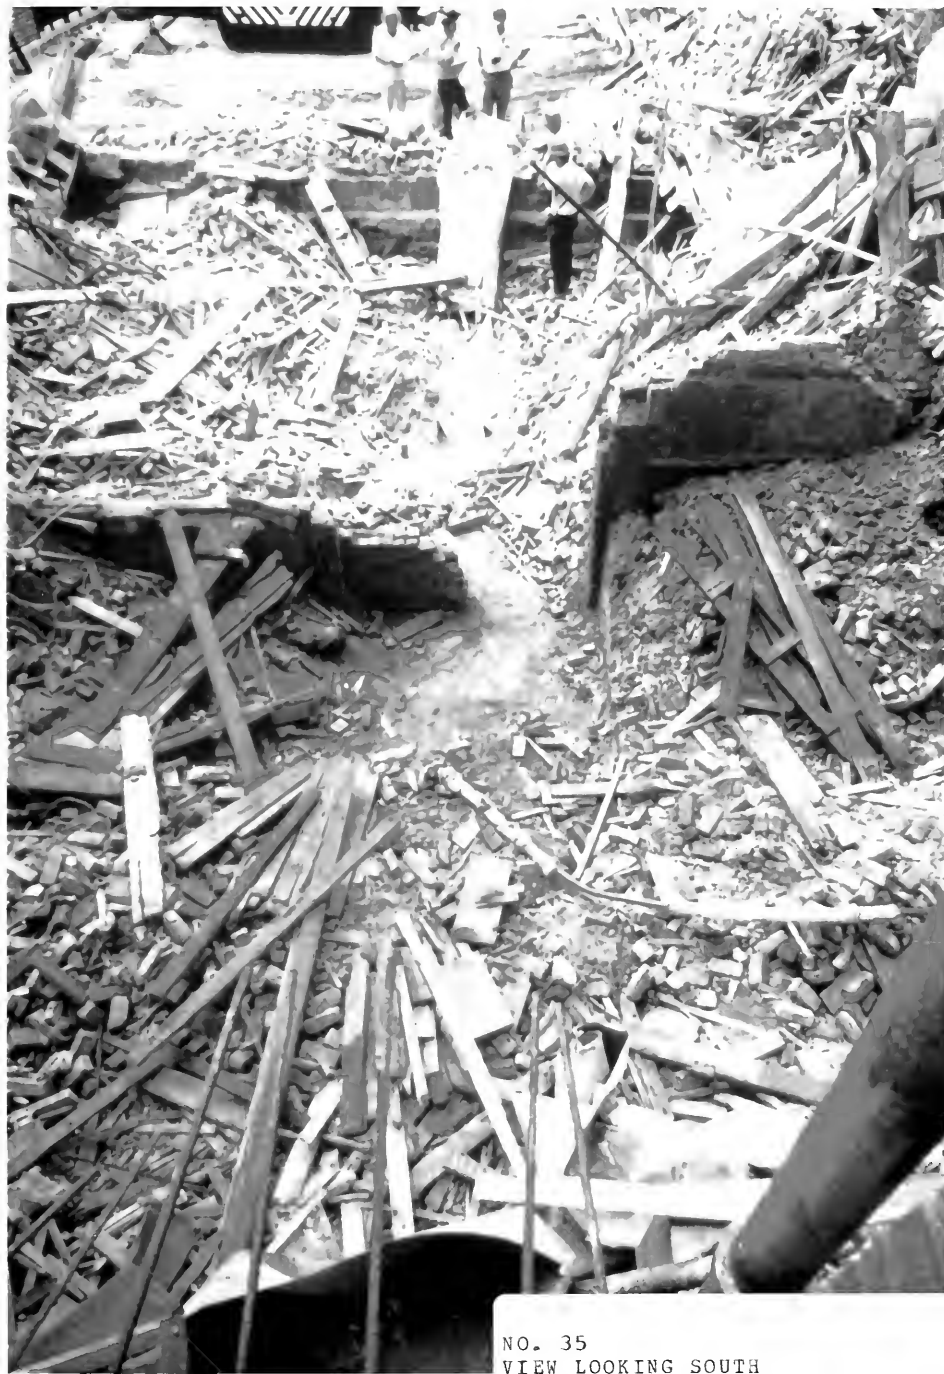
NO. 35
VIEW LOOKING SOUTH
AT COMPLETION OF SITE INVESTIGATION-
NEAR AND FAR ENDS OF
BASEMENT VENT DUCT SHOWN.

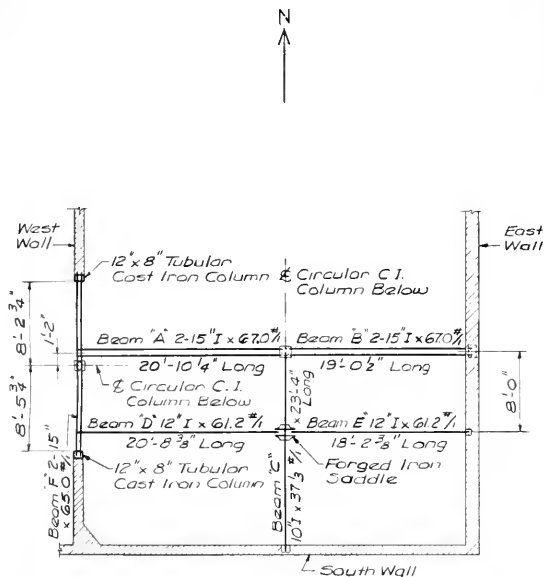
PLAN
RECONSTRUCTION OF 2ND FLOOR
SUPPORT FRAMING

Drawing R3 shows a plan view of this framing as reconstructed with data shown for the various beams.

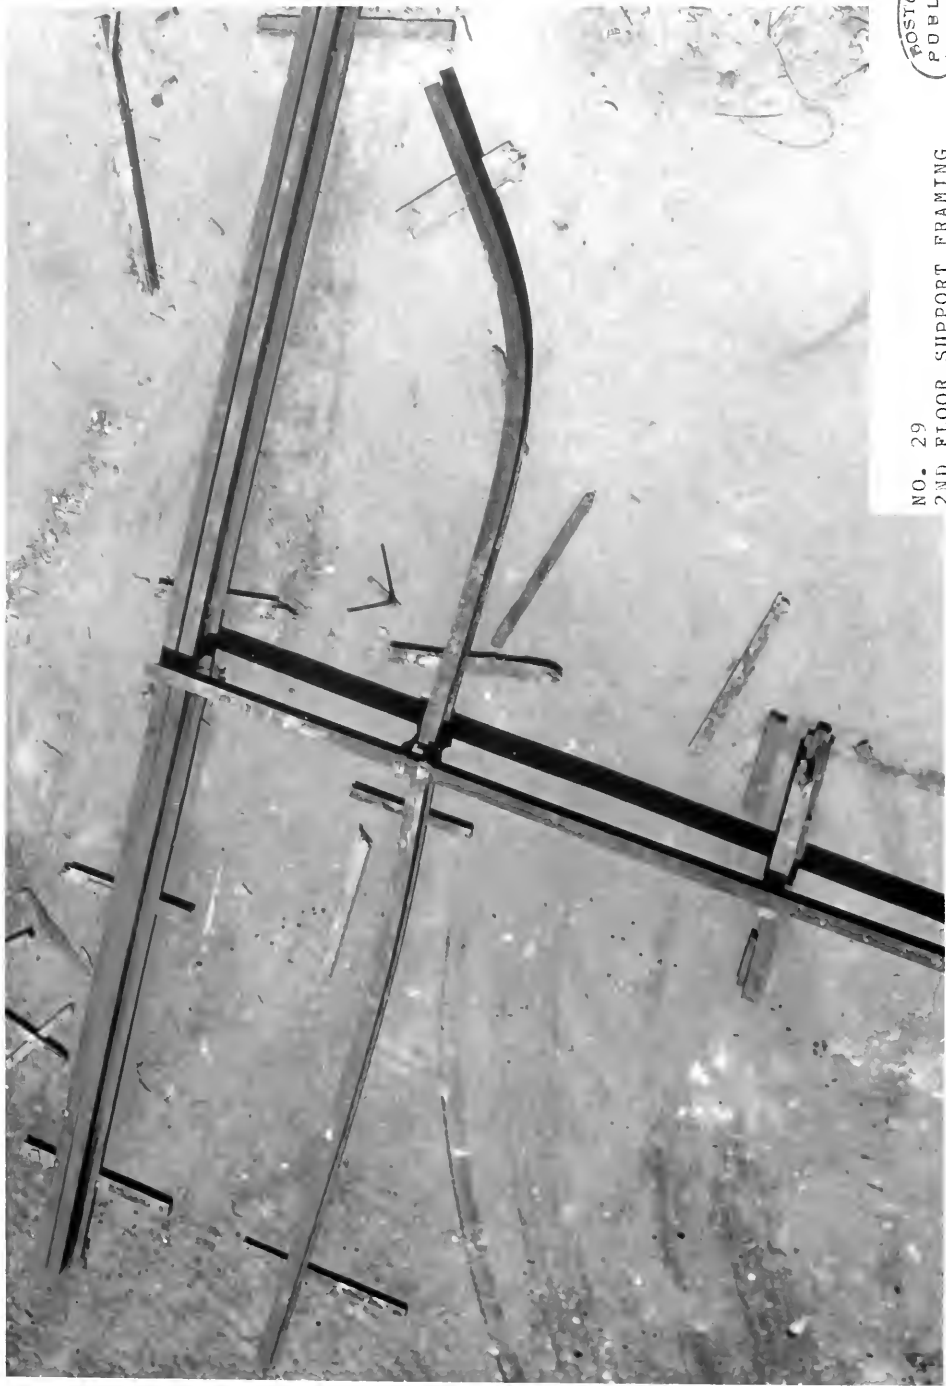
NO. 29

2ND FLOOR SUPPORT FRAMING
RE-ASSEMBLED IN PARKING LOT-
AS PHOTOGRAPHED FROM BUCKET ON CRANE.

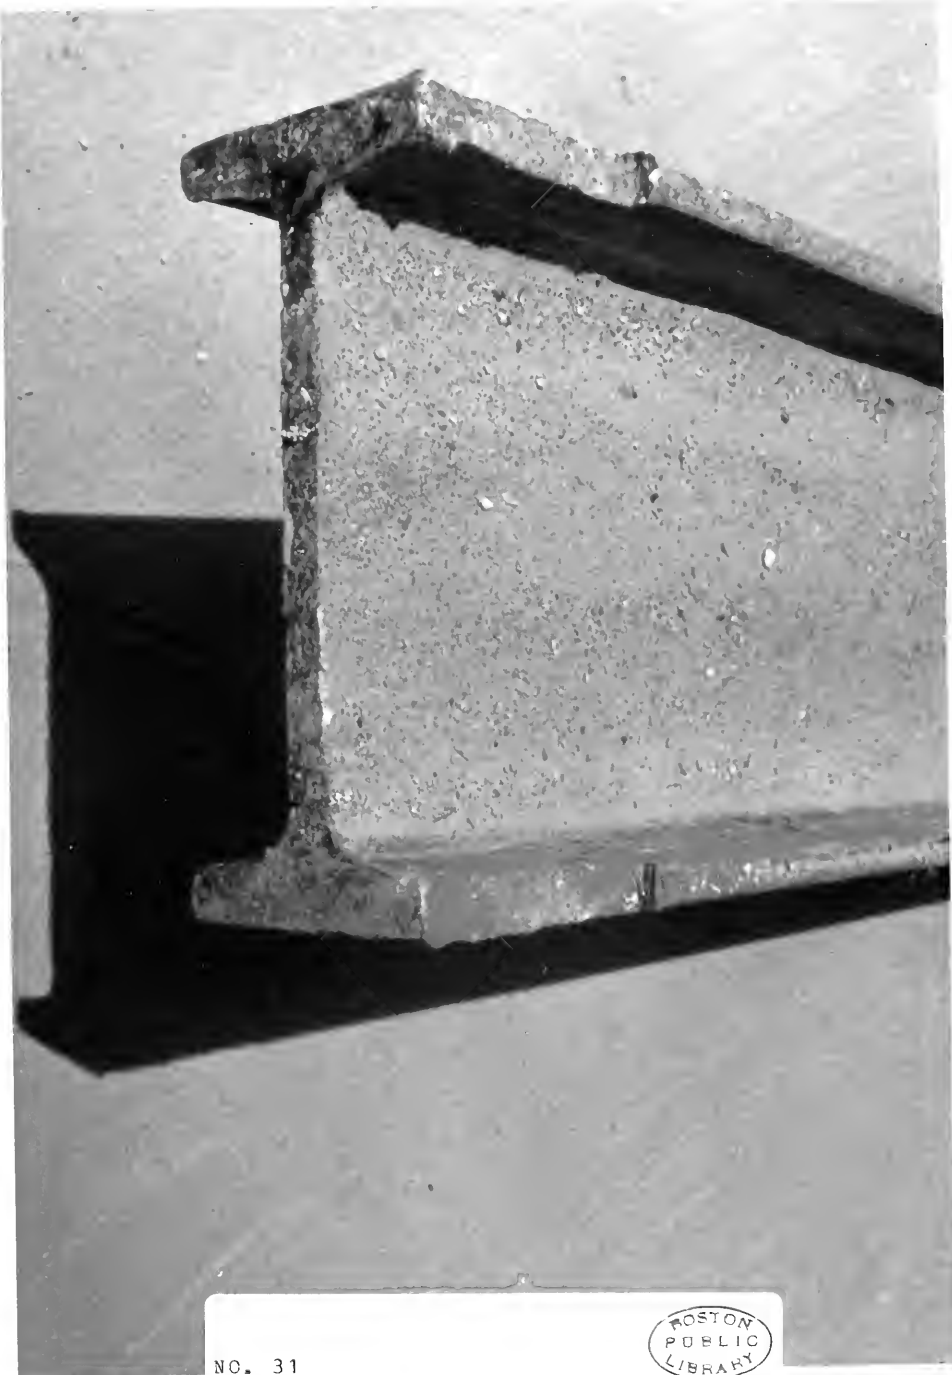
NO. 31

END OF 12 I BEAM ('D' OR 'E') -

NOTE FLANGE CUT TO FIT IRON SADDLE.

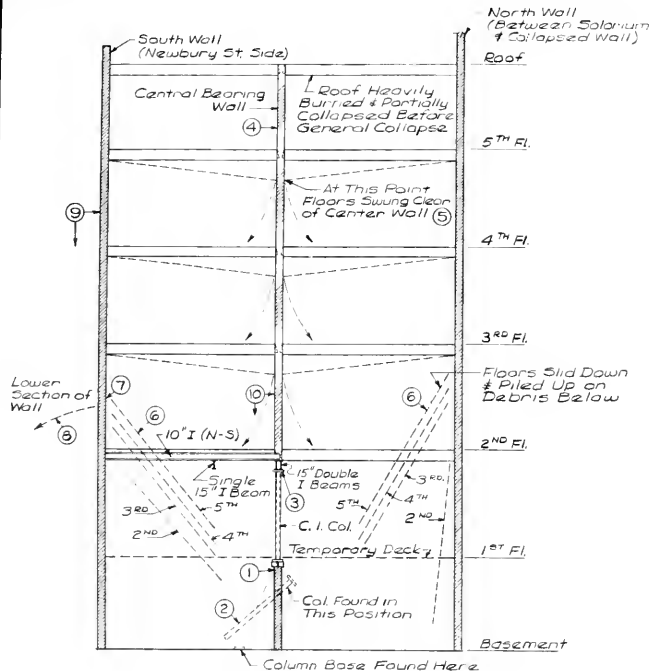
DIAGRAM OF COLLAPSE

It is our opinion that the collapse was initiated by a bearing and/or shear failure of the bearing wall under a single central column between the second floor and the first floor (upper concourse level). The failure allowed this cast-iron column to drop to the basement level resulting in a complete collapse of the upper floors. (See R5 and R6.)

- 1 Bearing Wall Fails Under Central Column
- 2 Column Falls into Basement
- 3 15" Double I Beams Drop in Center and Rotate Out of End Bearings
- 4 Central Wall Starts Dropping
- 5 When Central Wall Drops Two Feet, Floor Systems Slip Free
- 6 Floor Systems Swing Against Walls, Break Free and Slide into Basement
- 7 Floor Systems Lie Against Newbury Street Wall
- 8 Lower Portion of Newbury Street Wall Gives Way Under Pressure From Floors - Rotates Outward, Burying Fire Engine
- 9 Upper Part of Newbury Street Wall Collapses on Top of Debris
- 10 Meanwhile, Central Wall Has Fallen into Basement Along With Fragments of Roof

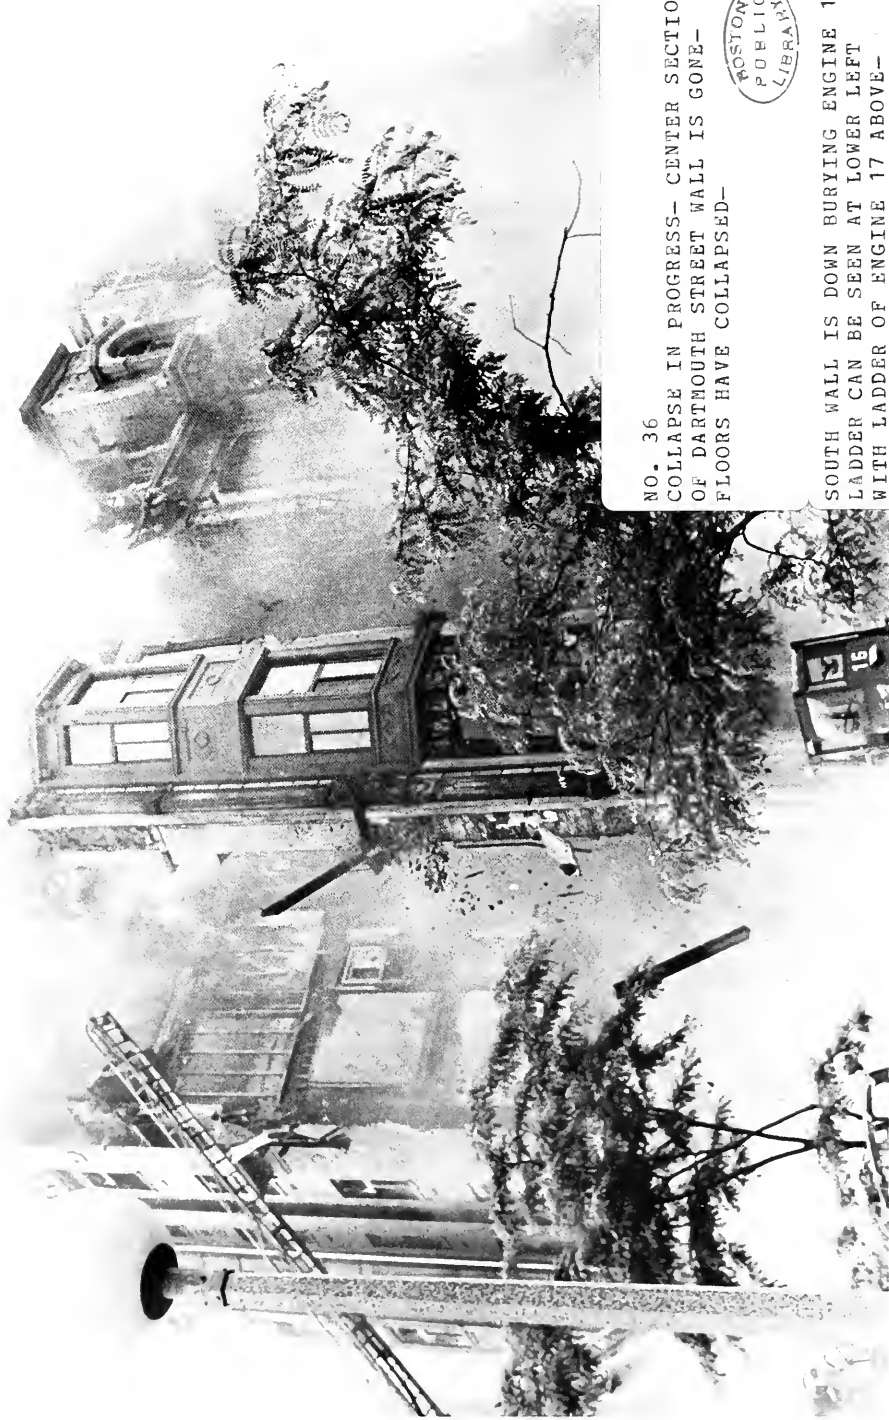
NO. 36

COLLAPSE IN PROGRESS- CENTER SECTION
OF DARTMOUTH STREET WALL IS GONE-
FLOORS HAVE COLLAPSED-

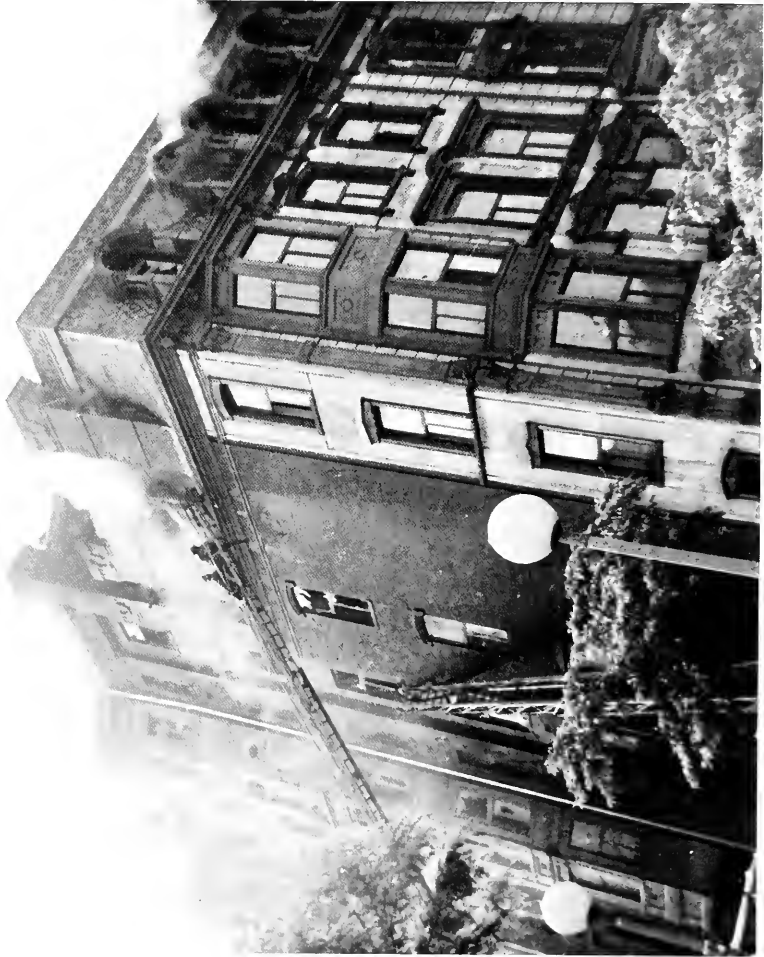
NO. 38
SOUTHEAST CORNER BEFORE COLLAPSE-
NOTE WINDOWS IN SOUTH WALL
BELOW CHIMNEY-
COMPARE THIS PHOTO WITH NO. 36
PHOTOGRAPH TAKEN BY JAMES B. FORGIE

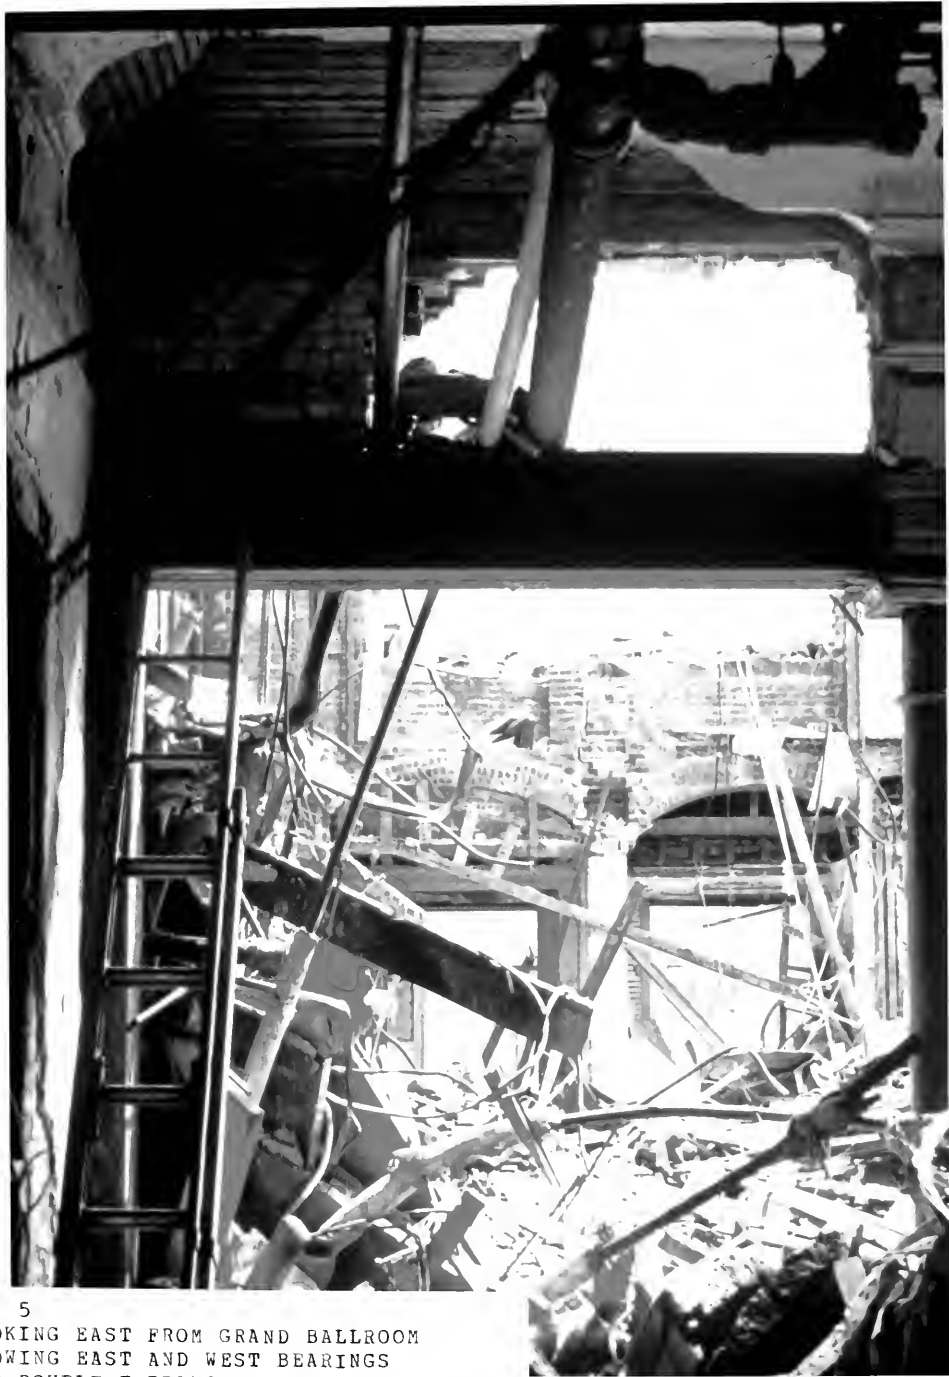
NO. 5
LOOKING EAST FROM GRAND BALLROOM
SHOWING EAST AND WEST BEARINGS
FOR DOUBLE I BEAMS—
END OF DOUBLE I BEAMS 'A'
VISIBLE IN DEBRIS BELOW

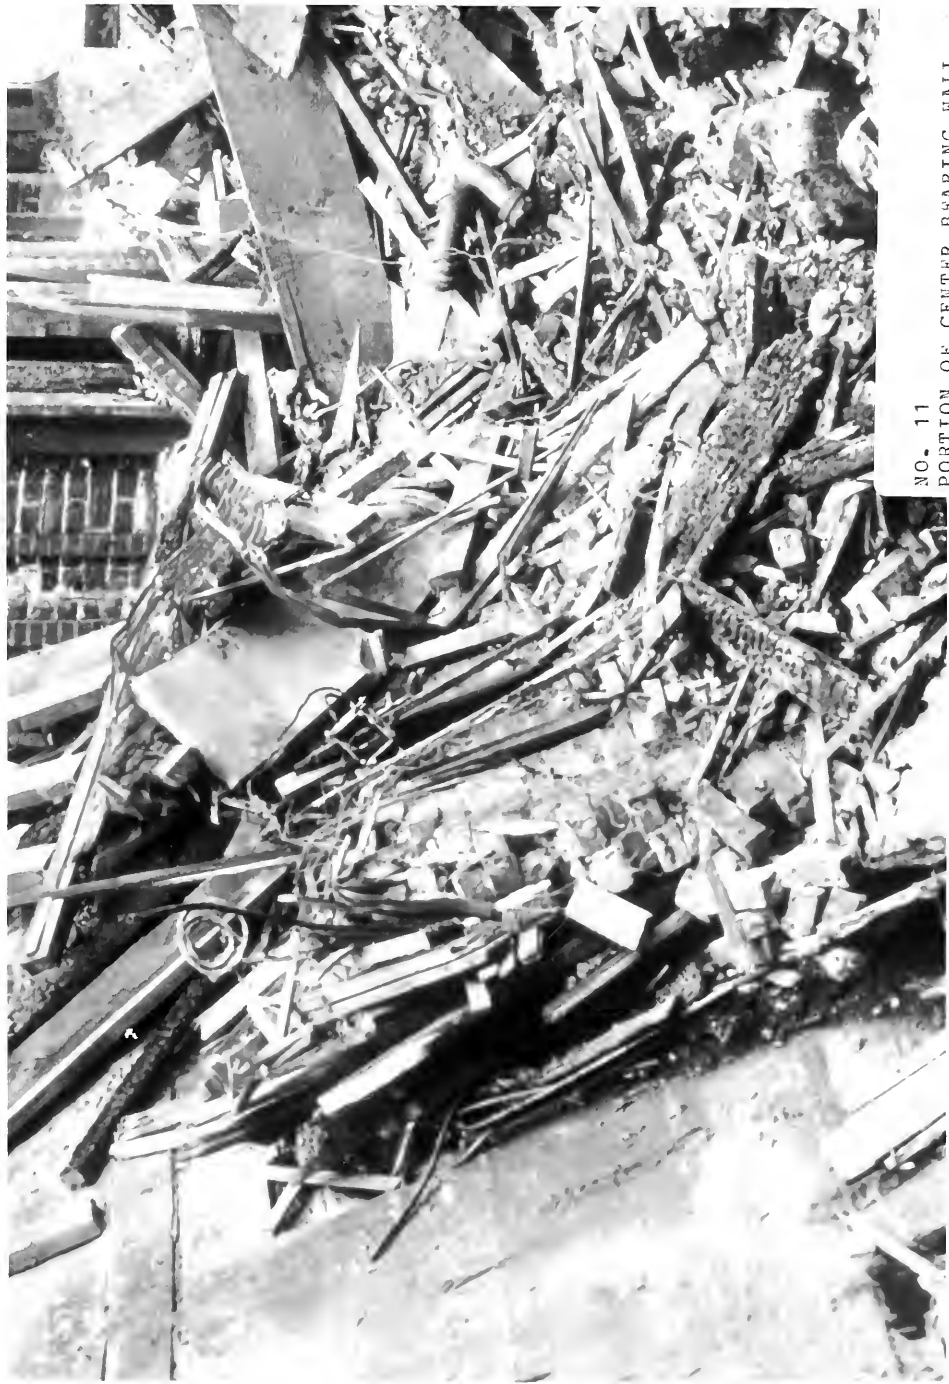
NO. 11

PORTION OF CENTER BEARING WALL
LAYING AGAINST 5TH FLOOR—
APPROXIMATELY FOUR STORIES
BELOW ORIGINAL POSITION.

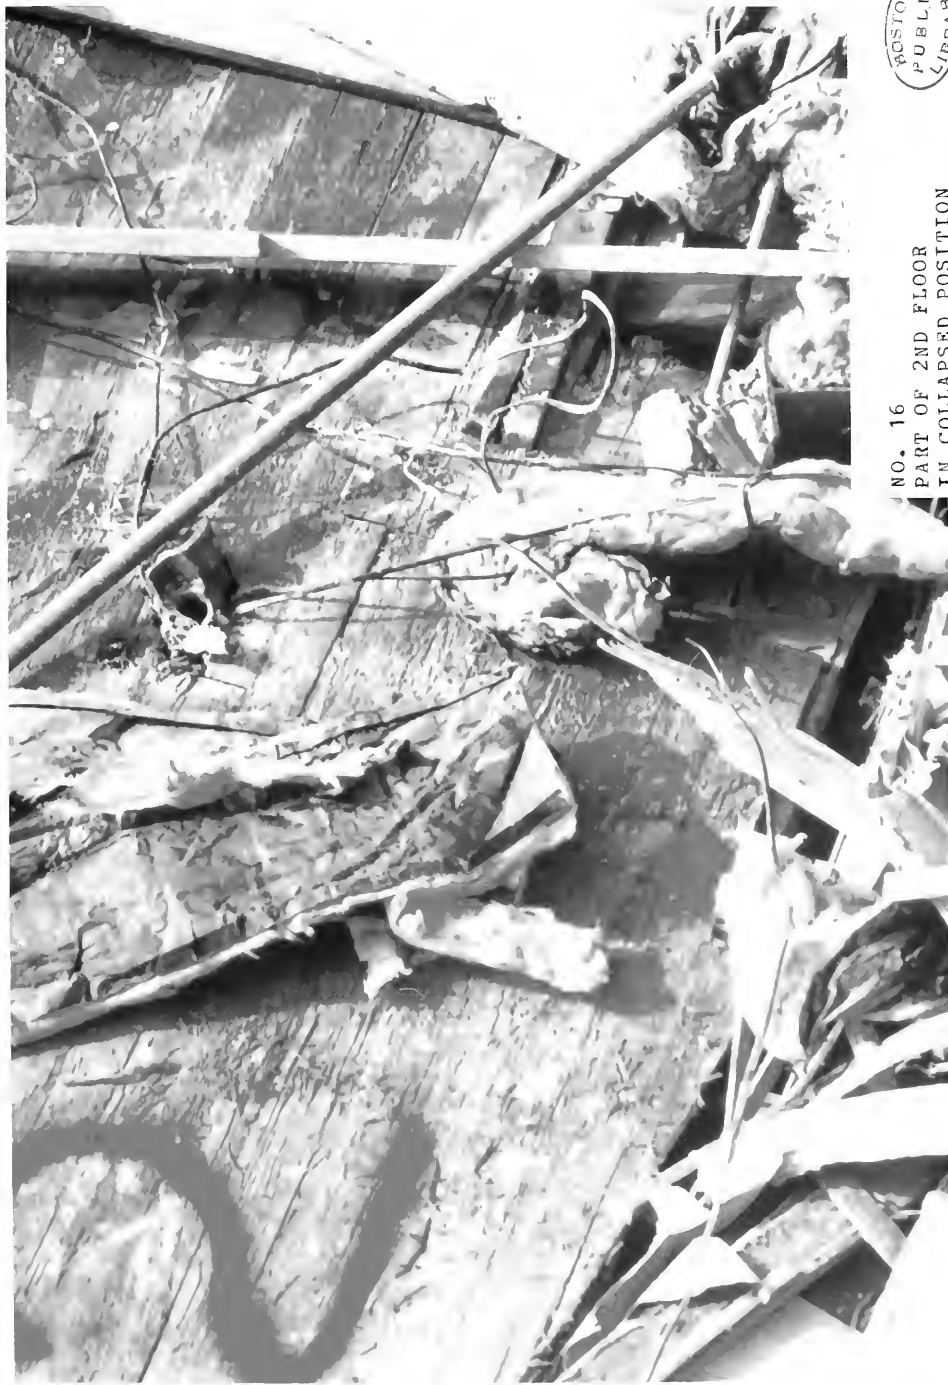
NO. 16
PART OF 2ND FLOOR
IN COLLAPSED POSITION
AND IMPALED ON STEEL BEAMS.

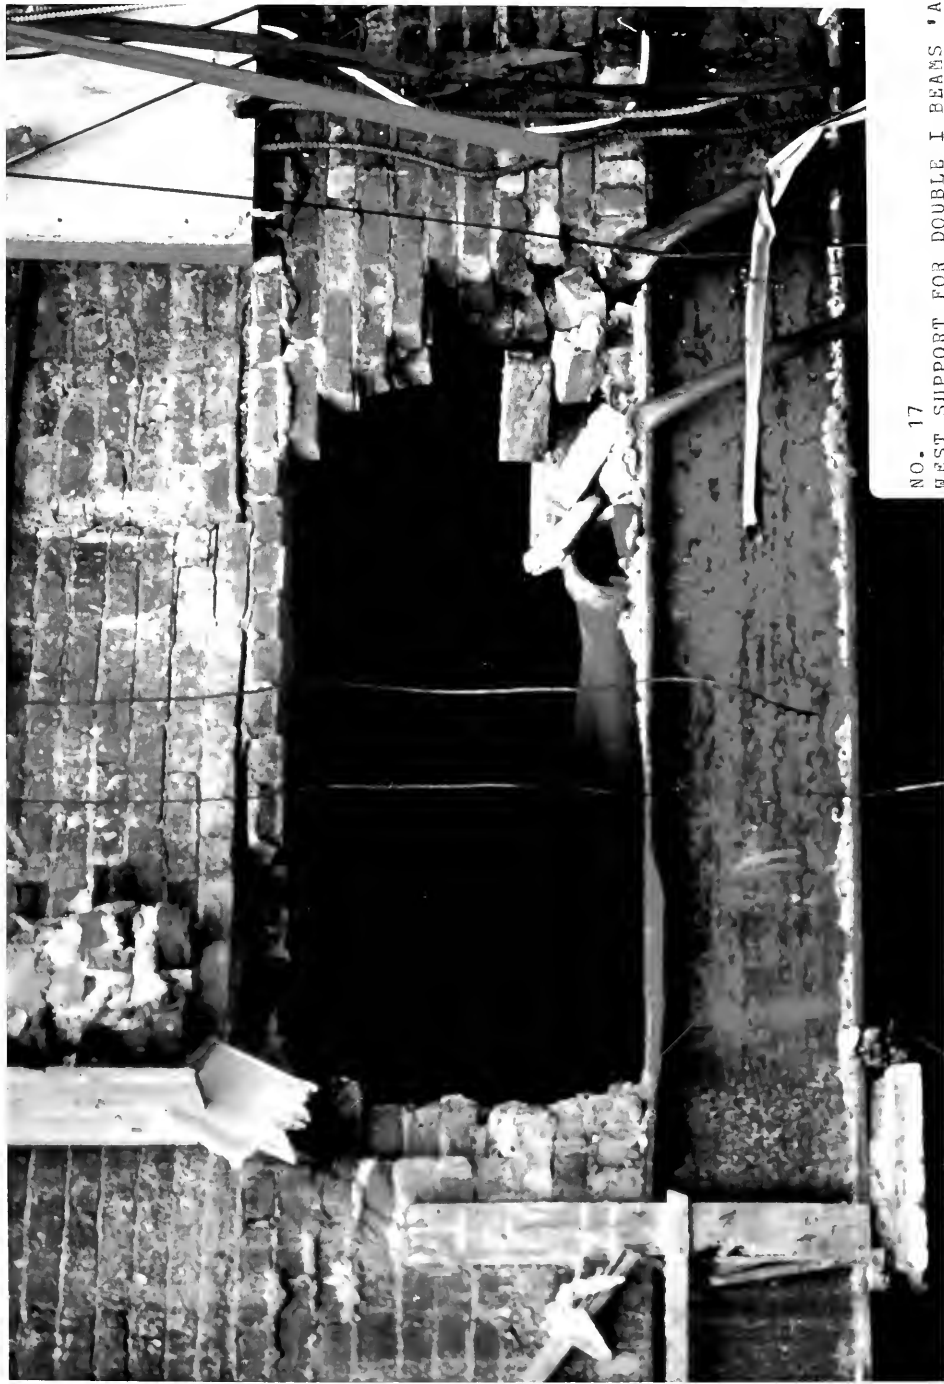
NO. 17

At the West side, the double-I-beams were supported by another set of double beams running north and south. A large rotational force was also set up at this point; a flange of the supporting beam was bent and cracked and a section of brickwork was torn out of the West side bearing wall. The floors in the main part of the building tied into the opposite side of this wall and may have prevented a progression of the collapse in this direction.

WEST SUPPORT FOR DOUBLE I BEAMS 'A'-
NOTE BENT FLANGE AND SECTION
TORN OUT OF WEST WALL

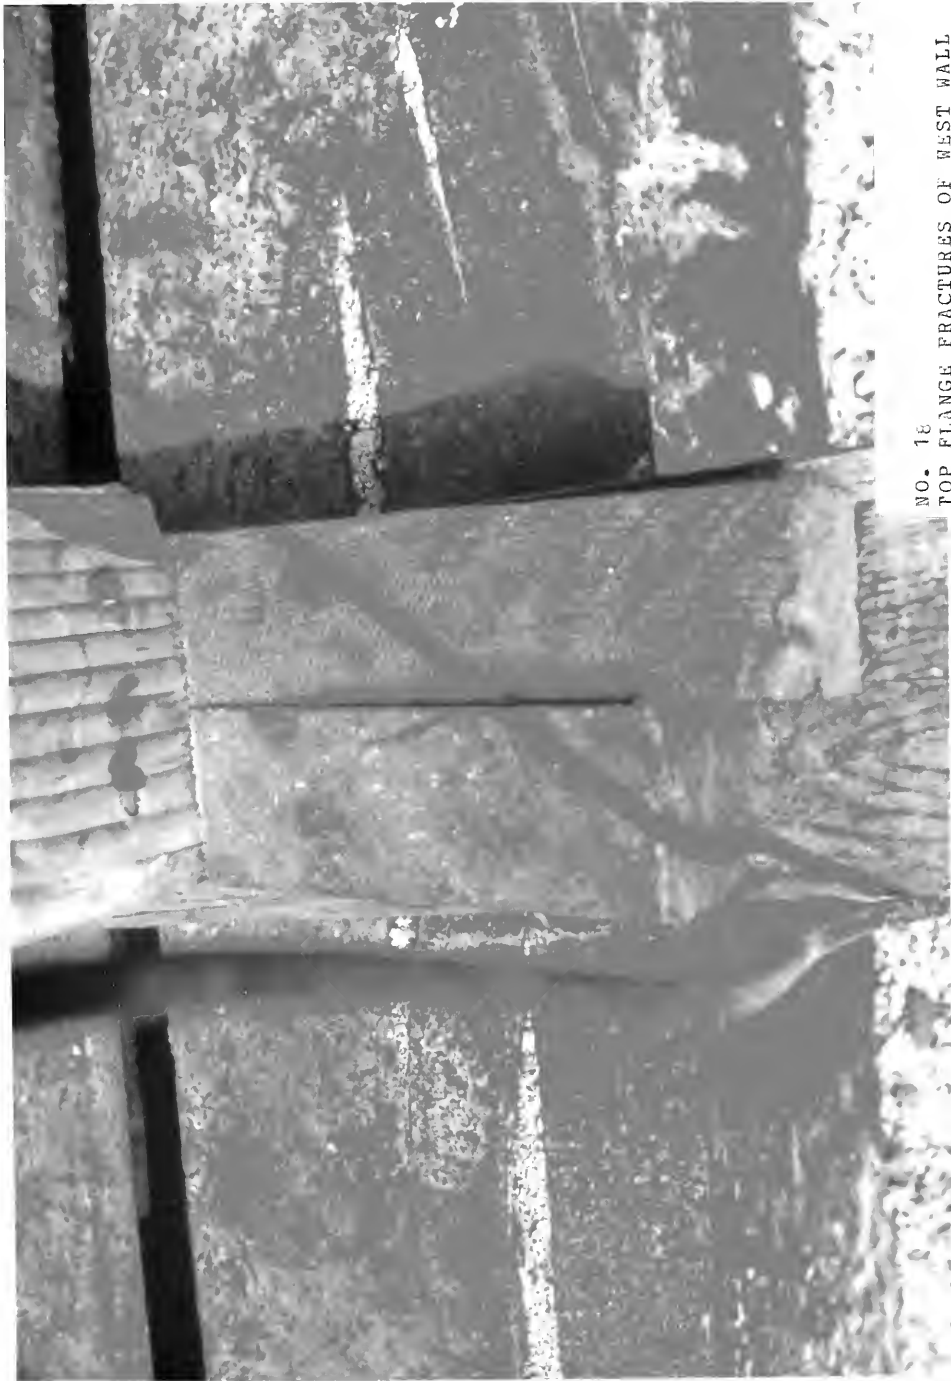
NO. 18

TOP FLANGE FRACTURES OF WEST WALL
BEAM 'F' AT SUPPORT POINT
OF DOUBLE I BEAM 'A'

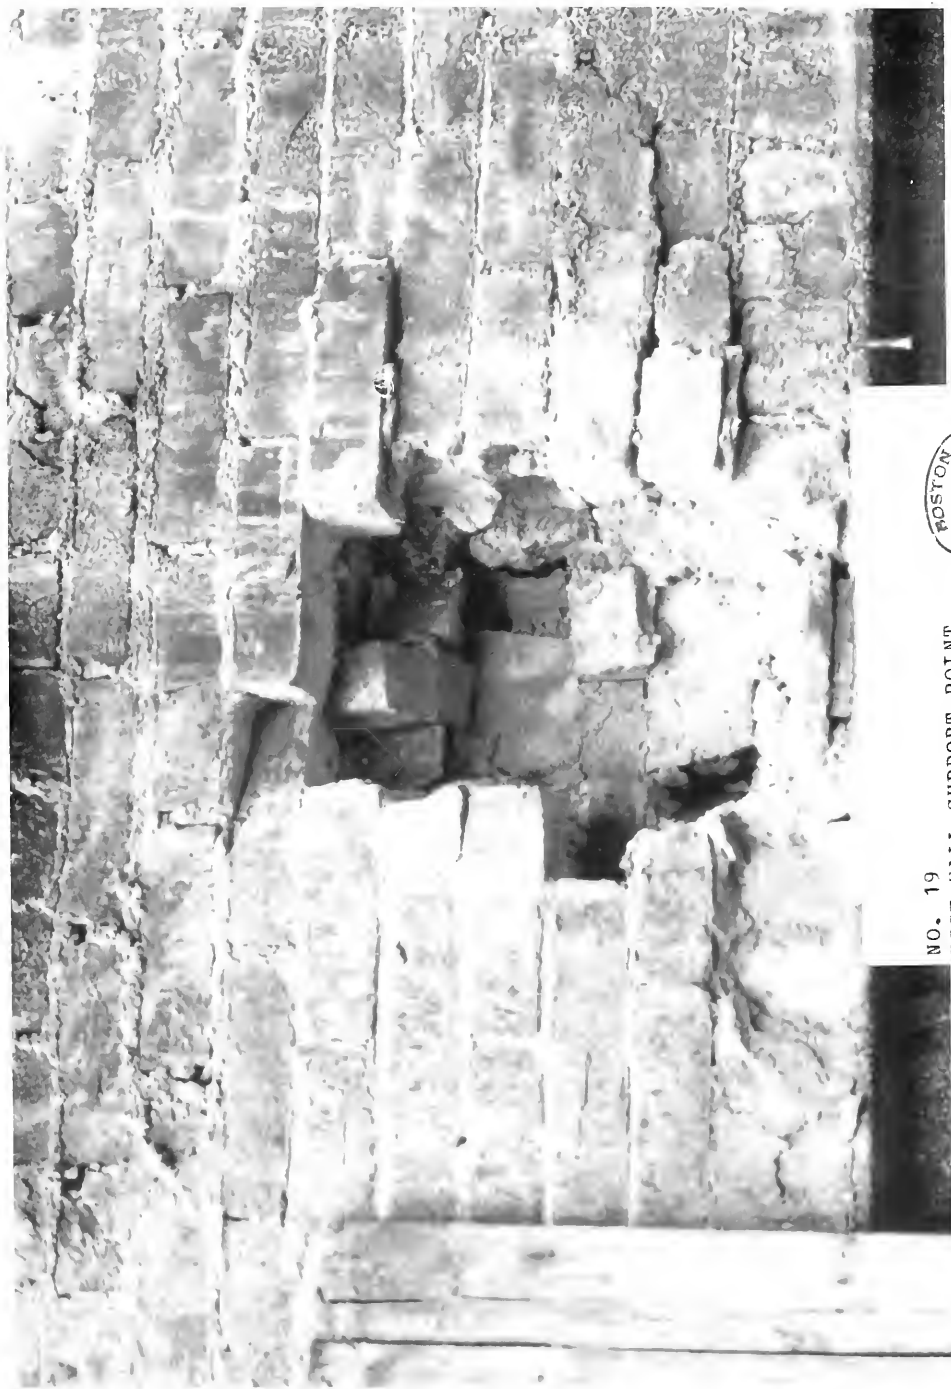
NO. 19
WEST WALL SUPPORT POINT
FOR SINGLE I BEAM 'D'

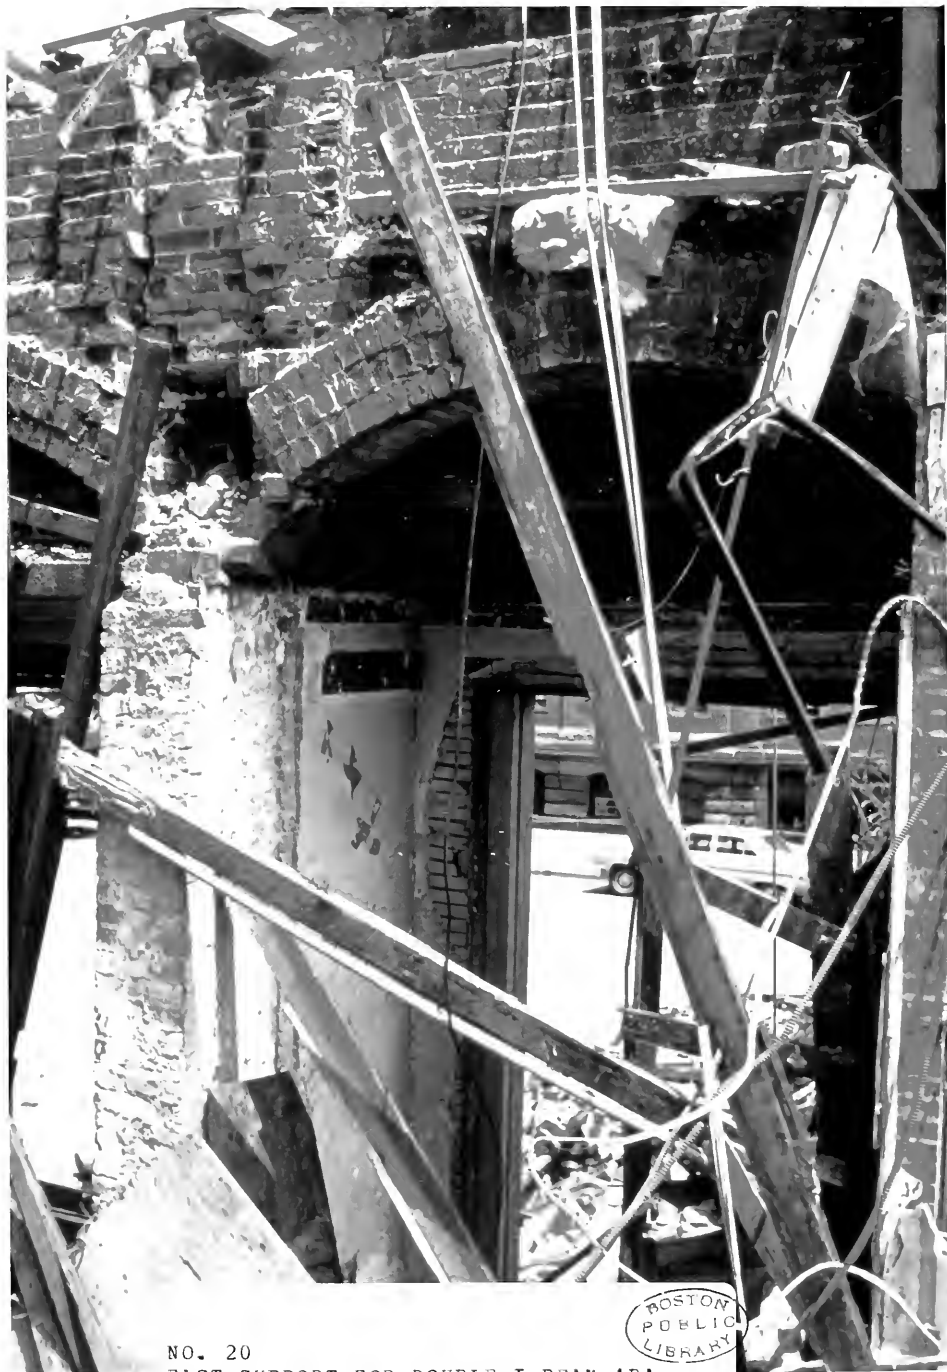
NO. 20

EAST SUPPORT FOR DOUBLE I BEAM 'B'—

NOTE BRICKS TORN OUT BY BEAM ROTATION.

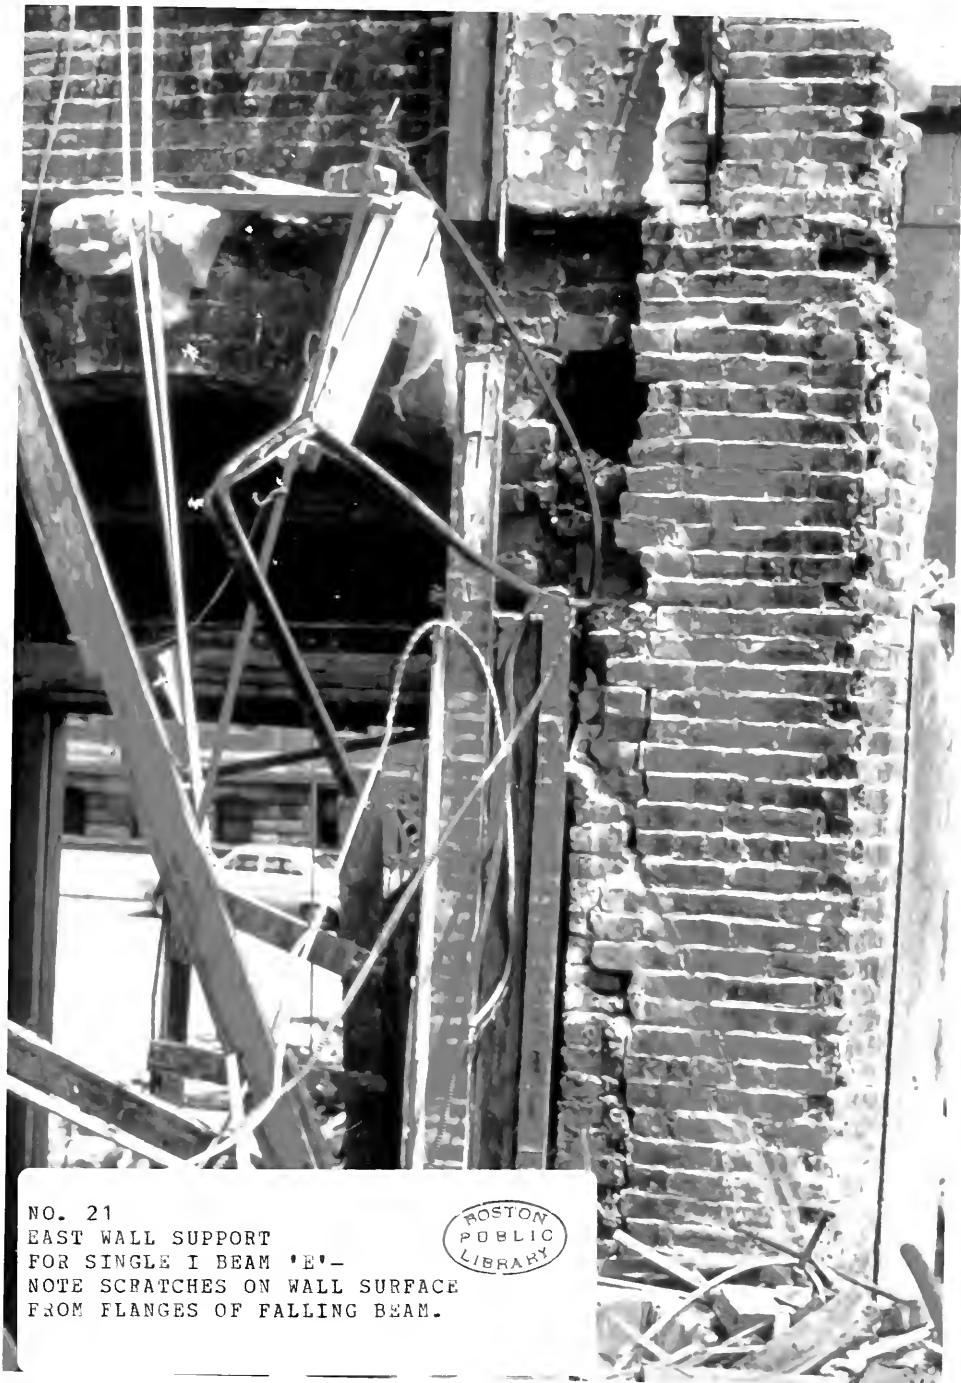
NO. 21
EAST WALL SUPPORT
FOR SINGLE I BEAM 'E'-
NOTE SCRATCHES ON WALL SURFACE
FROM FLANGES OF FALLING BEAM.

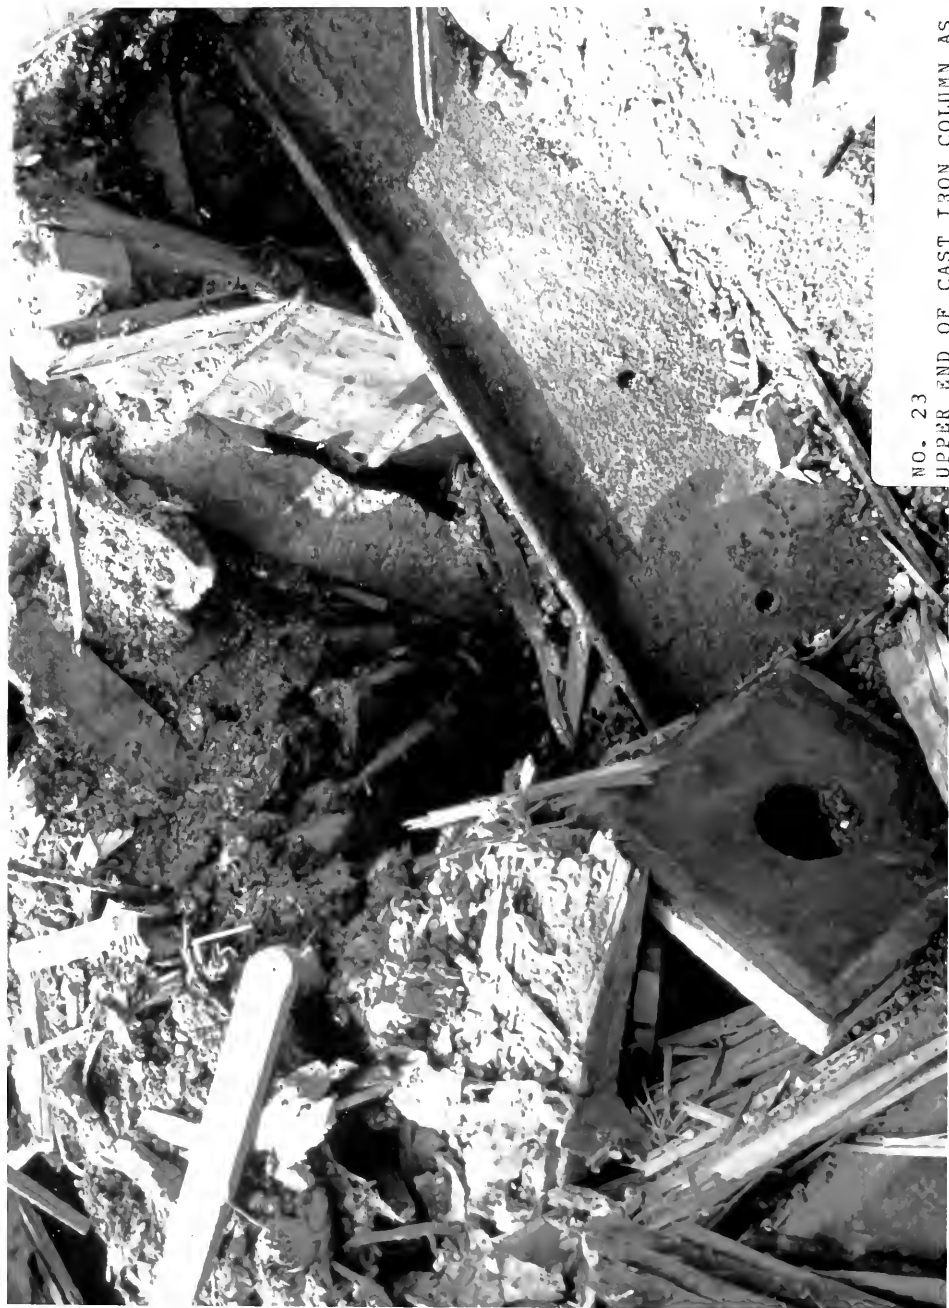
NO. 23

UPPER END OF CAST IRON COLUMN AS FOUND-
WEST SIDE DOUBLE I BEAM 'A' AT RIGHT-
NOTE GRANITE BEARING BLOCK
RESTING ON END IN DOOR OPENING.

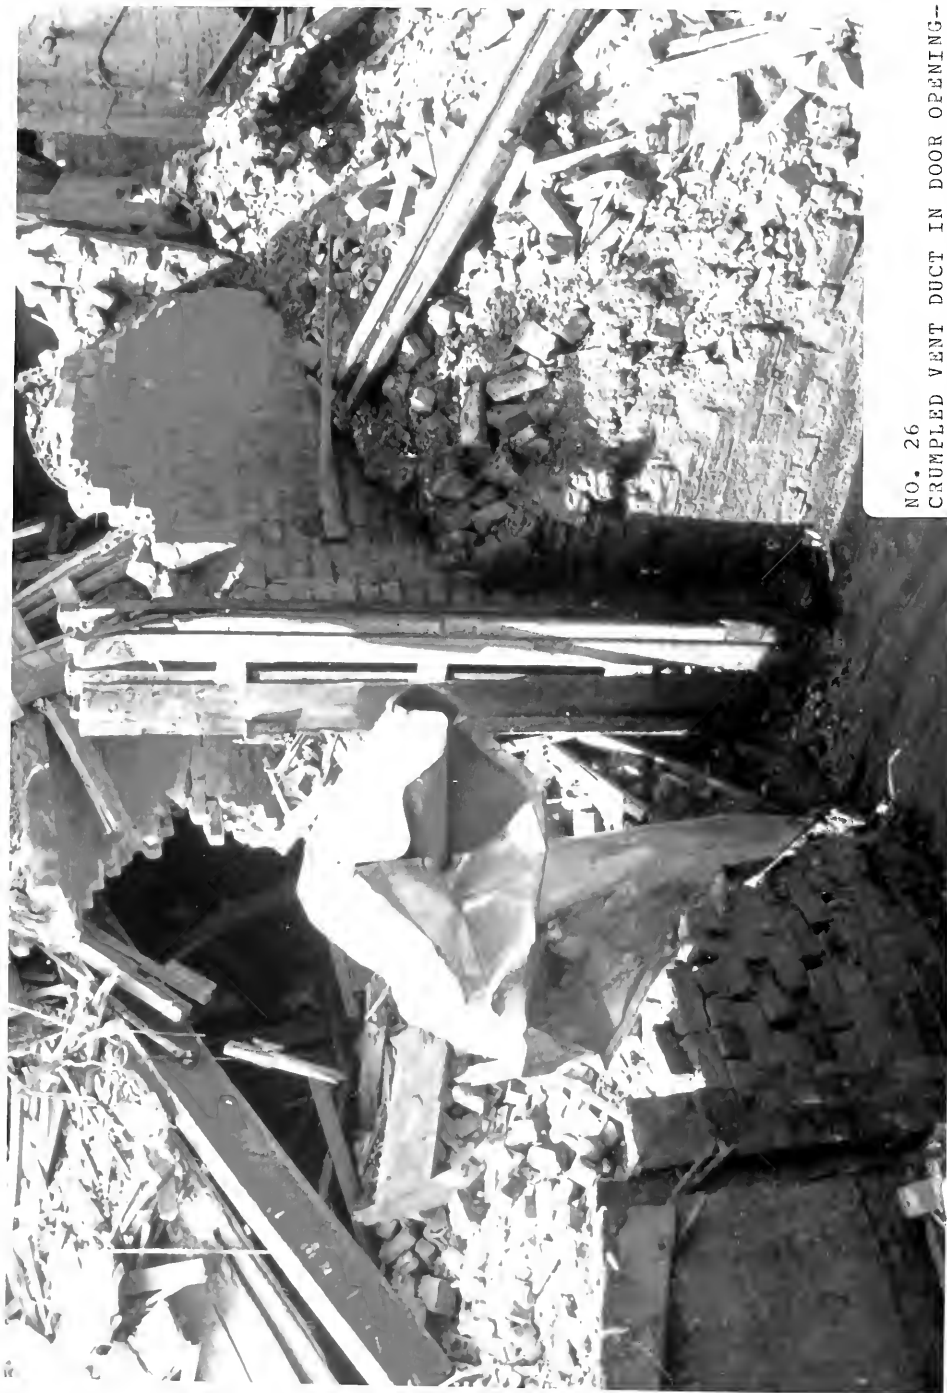
NO. 26

CRUMPLED VENT DUCT IN DOOR OPENING--
ALL DEBRIS CLEARED AWAY NORTH OF WALL--
NOTE DENT IN DUCT WHERE COLUMN RESTED.
